# Manhole Inspection Summary

Manhole # S33S\_\_041MH

Insp Date: **2/5/08 4:08 PM**

**Location** Address: **race st**

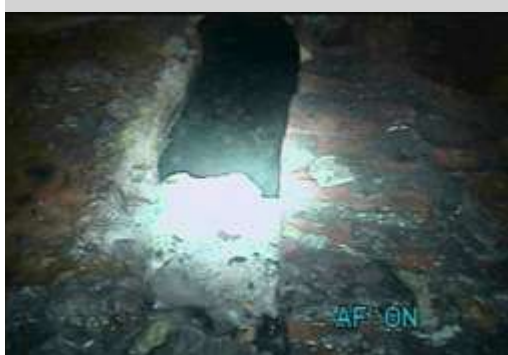
Defect 3

Condition: ☐ Sound ☐ Cracked ☐ Root Intrusion ☐ Deteriorated ☐ Leaks ☒ **Debris**

channel debris

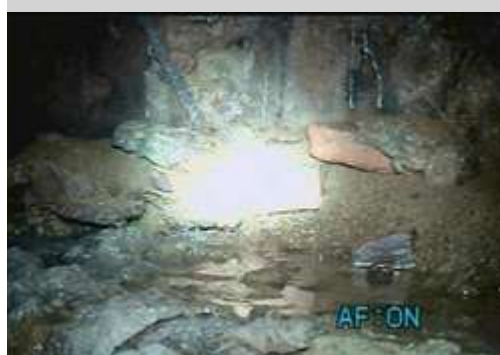
Defect 2

Condition: ☐ Sound ☐ Cracked ☐ Root Intrusion ☐ Deteriorated ☐ Leaks ☒ **Debris**

bench debris

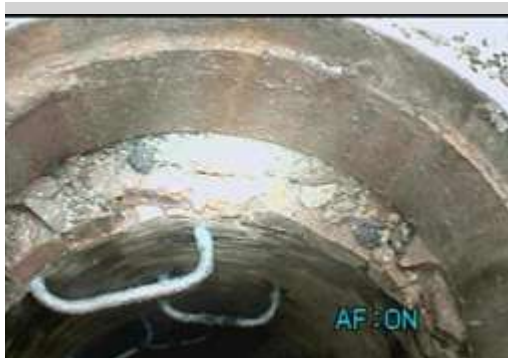
Defect 1

**Frame** Offset: **3** (in.) Condition: ☒ Sound ☐ Cracked ☐ Leaks

offset

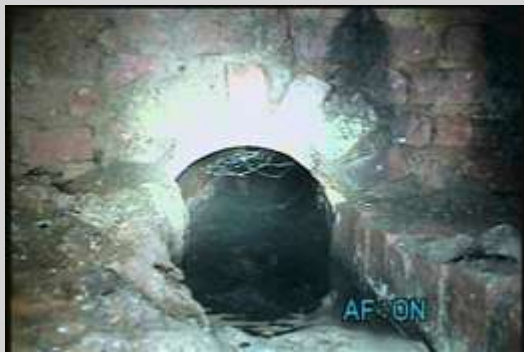
12 O'Clock Outflow

15 in. Circular Gravity Sewer  
Pipe Out @ 12 O'Clock

Deposits: ☒ None ☐ Mud ☐ Gravy ☐ Debris ☐ Grease

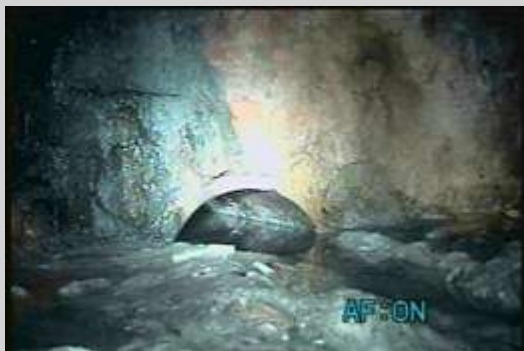
6 O'Clock Inflow

8 in. Circular Gravity Sewer  
Pipe In @ 6 O'Clock

Deposits: ☐ None ☒ Mud ☒ Gravy ☐ Debris ☐ Grease

Silt Depth: 4 (in.) Deposits Extent: Heavy
